## DURABILITY AND BEHAVIOR OF PRESTRESSED CONCRETE BEAMS

Report 4

POSTTENSIONED CONCRETE BEAM INVESTIGATION  
WITH LABORATORY TESTS FROM JUNE 1961 TO  
SEPTEMBER 1975

Edward F. O'Neil

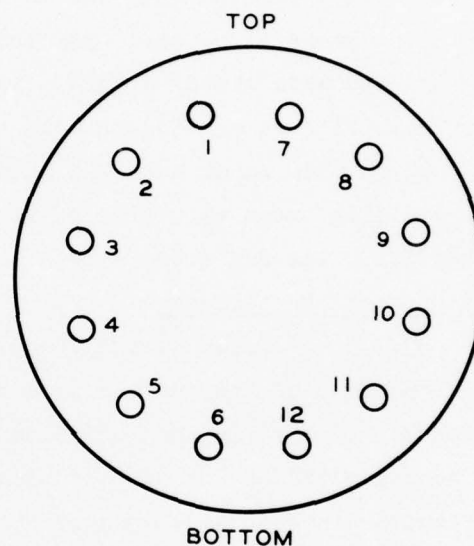
Figure 4. Landward end anchorage, beam 3

36. The 1-1/4-in. length of each strand that protruded from the end of the anchorage was rusted to varying degrees. Some of the strands were only slightly rusted, while some were corroded to the point that parts of their volumes had been eaten away.

37. Using the nomenclature in Figure 4, the steel strands that protruded from the end of the anchorage were corroded (Photo 1) as follows:

<u>Strand</u>	<u>Volume Missing percent</u>	<u>Strand</u>	<u>Volume Missing percent</u>
1	10	7	85
2	Mild rusting*	8	100
3	Mild rusting*	9	40
4	Mild rusting*	10	Mild rusting*
5	Mild rusting*	11	35
6	10	12	60

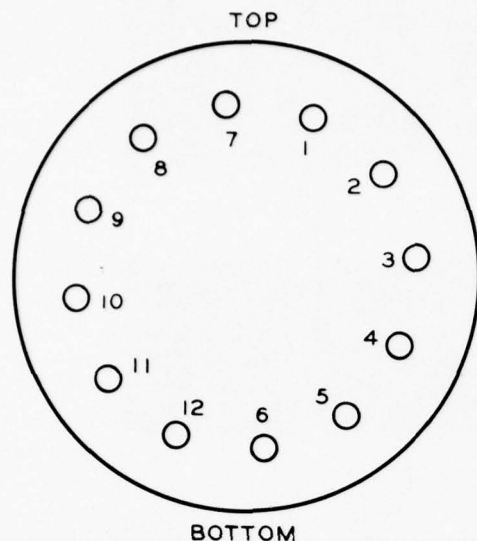
Figure 14. Landward end anchorage, beam 1

end of the anchorage was either heavily rusted or tarnished. The mortar within the steel coil of this end anchorage was an epoxy mortar. The two other beams that had this type posttensioning and were evaluated under this program (beams 3 and 6) did not have this epoxy in the mortar of the end anchor. One of the observations made when this end was opened was that the strands were either partially or entirely coated with epoxy. It appeared that after the epoxy mortar had been placed around the end anchorage, some of the epoxy bled out of the mortar and

coated the strands. All the strands were heavily corroded, and using the nomenclature in Figure 14, the steel strands were corroded as follows:

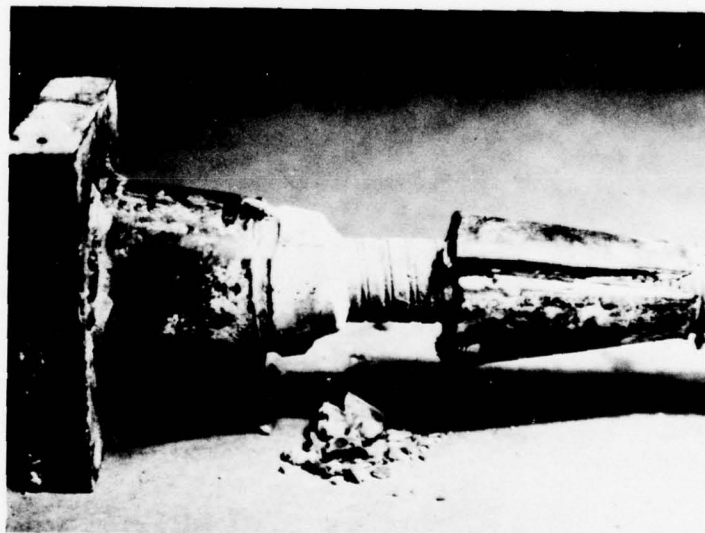
Photo 4. Grout in the landward end housing of beam 9 leaving cavity between housing and conduit

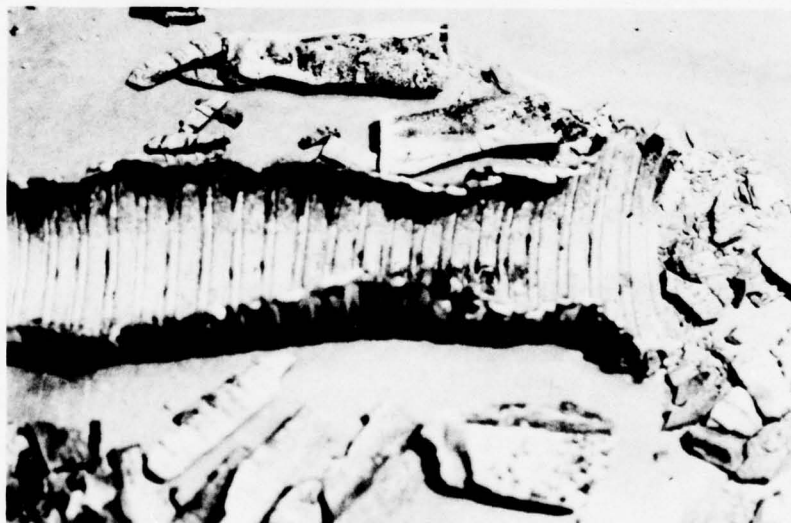
Photo 8. Seaward end of conduit in beam 9 at the funnel housing and an isolated patch of heavy rust

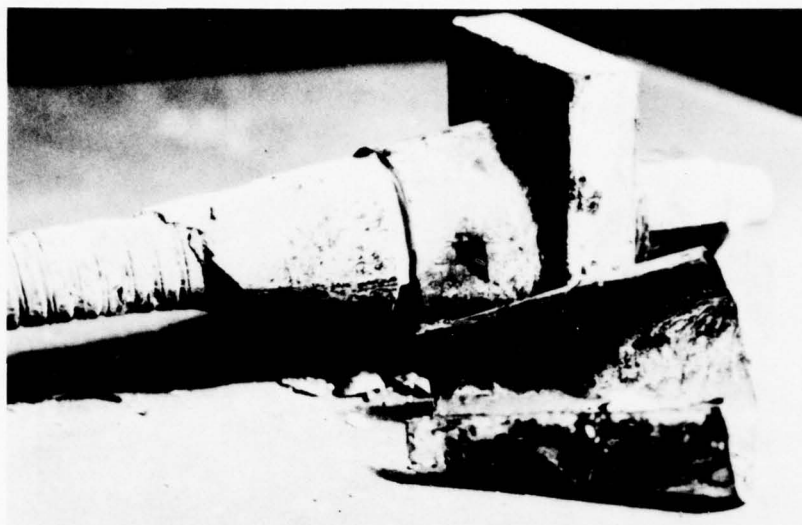
Photo 9. Condition of the seaward end anchor of beam 9

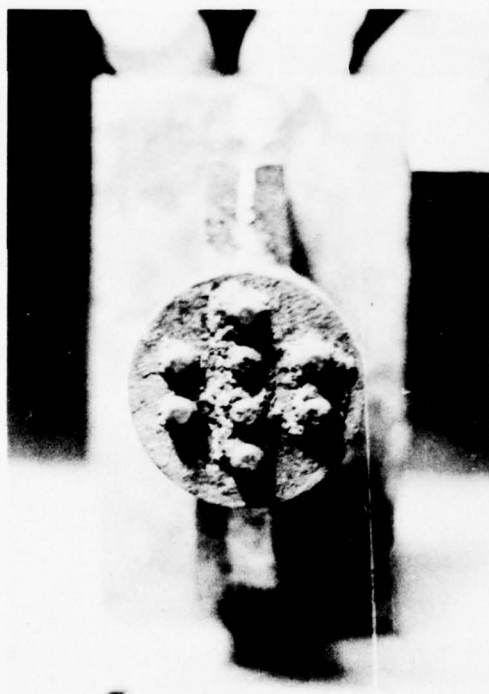
Photo 10. Grout around the ends of strands in beam 13 discolored by rust

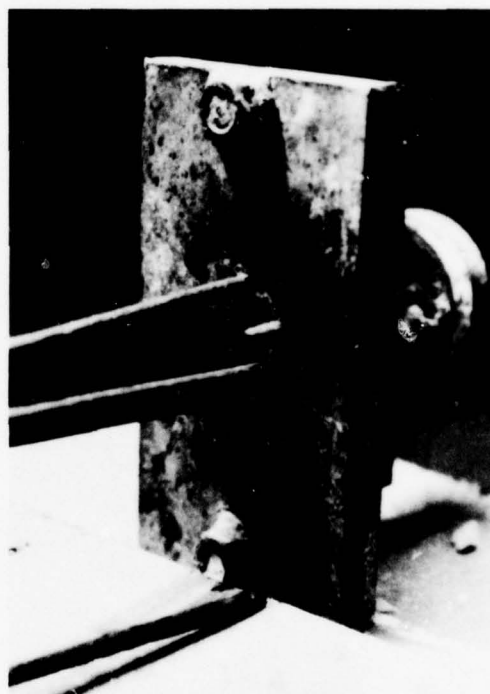
Photo 11. Edges of the landward end anchor of beam 13 lightly to moderately rusted. Note heavy rust to strands and broken strand just inside end plate

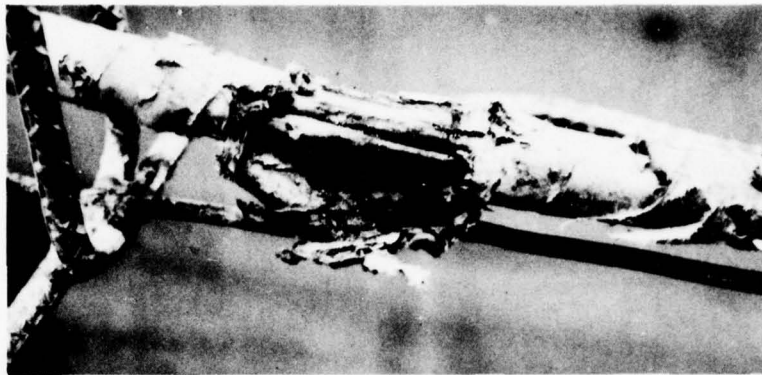
Photo 12. Paper-type wrapping in beam 13 torn,  
exposing grease and strands

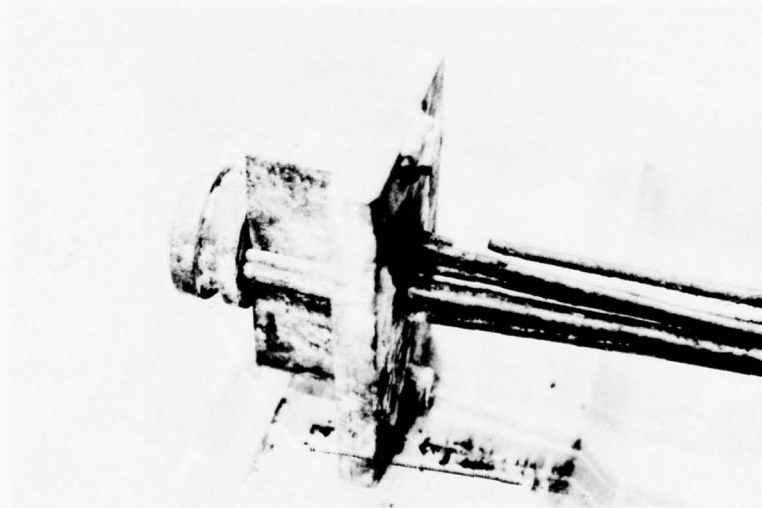
Photo 14. Strand in beam 13 so badly rusted that it  
broke about  $\frac{5}{8}$  in. from inside face of the end  
anchorage

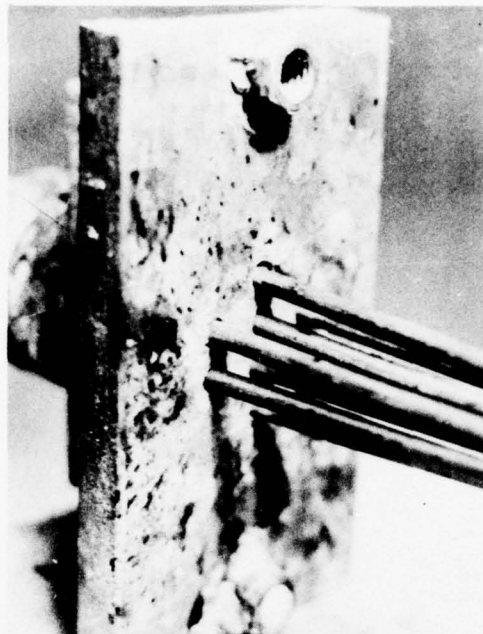
Photo 16. Inside face of the seaward anchorage of beam 13 exhibiting tarnishing and pitting

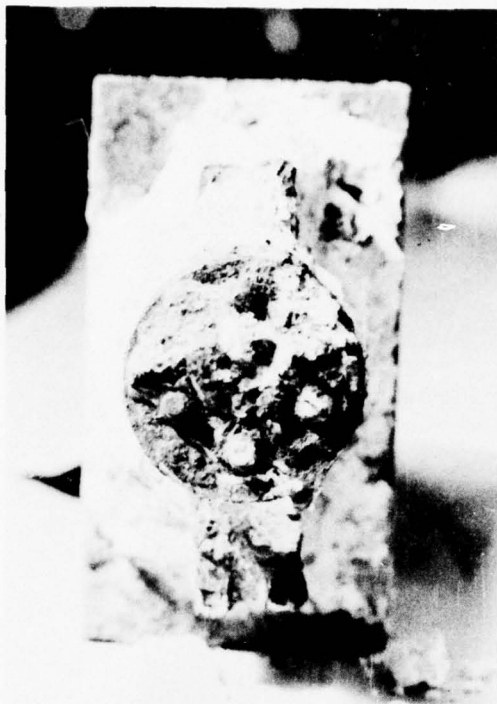
Photo 18. Outside of the landward end anchorage of beam 15 showing extent of rust and concrete cover

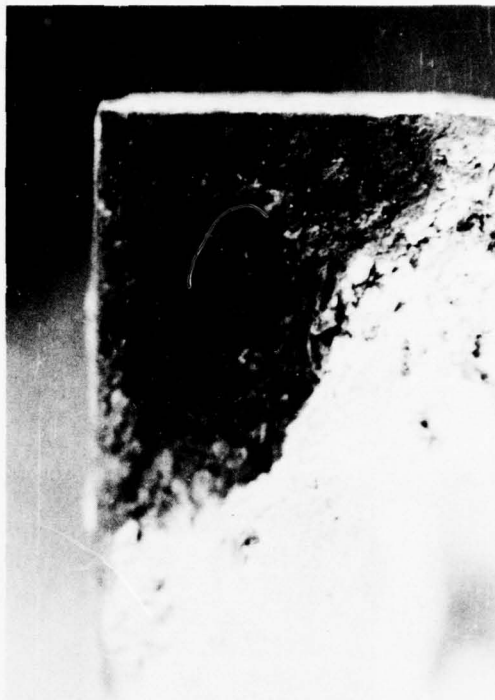
Photo 19. Detail of Photo 18 showing how surface of steel was rusted under the concrete cover

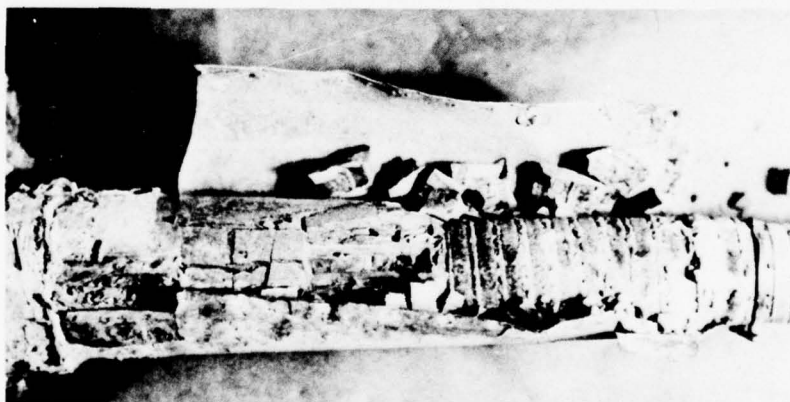
Photo 20. In beam 15, portion of conduit at the landward end that was heavily rusted with tiny pitting rust spots

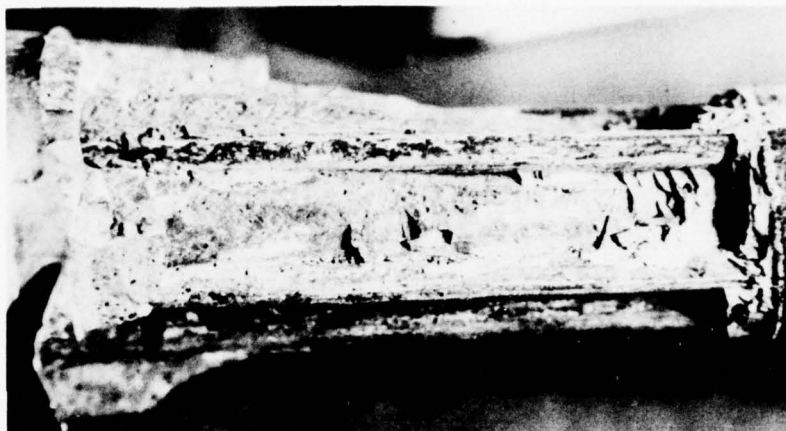
Photo 21. Strands beneath the landward end housing in beam 15 with moderate rust cover

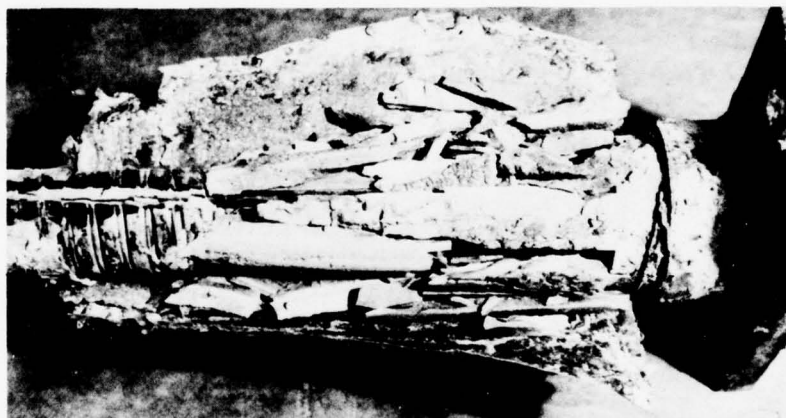
Photo 22. Weak grout and lustrous conduit beneath the seaward end housing in beam 15

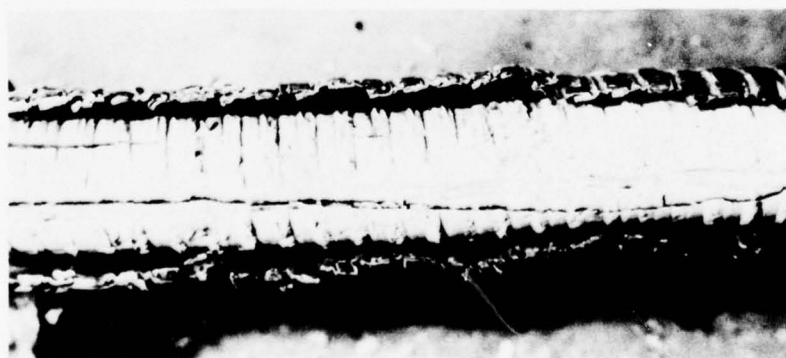
Photo 23. Grout at the seaward end in beam 15 just after conduit was opened. Note longitudinal crack, relieving the remaining stress in the steel

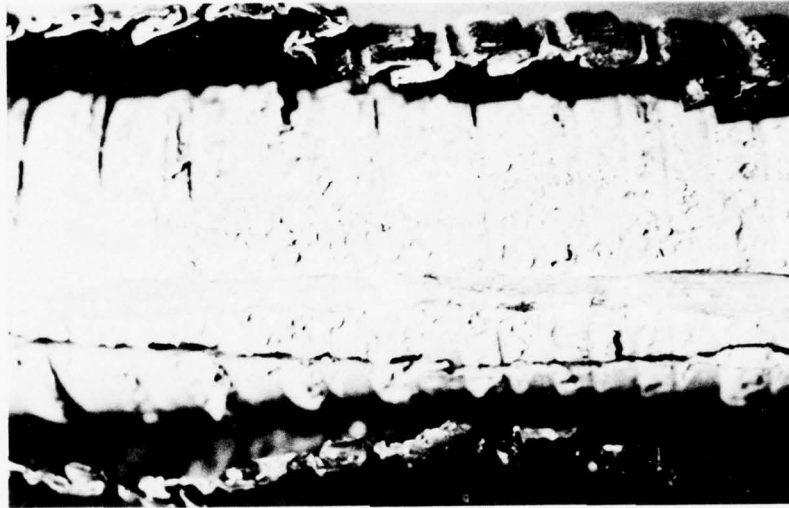
Photo 24. Detail of Photo 23 showing laitance and air voids in the grout

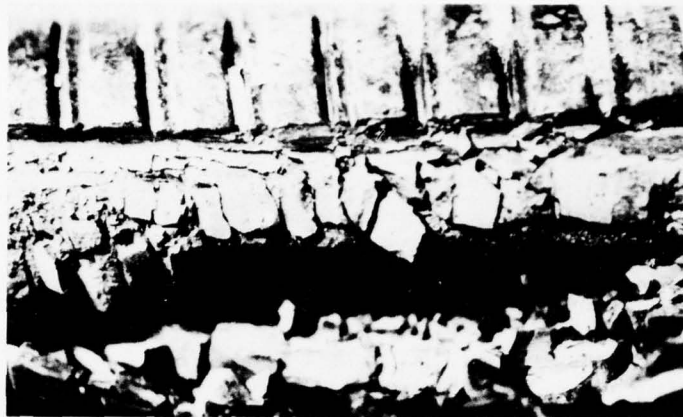
Photo 26. Grout at top of conduit near the landward end of beam 15. Note thin grout due to closeness of strands to top of conduit

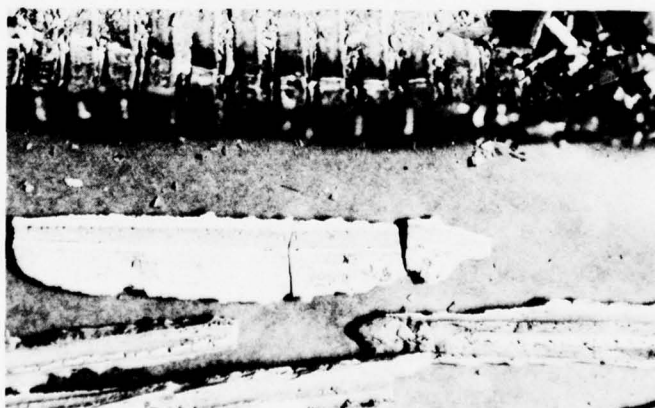
Photo 28. Grout from conduit at the seaward end of beam 15. Note milky white powder (calcium carbonate) covering grout and area of conduit from which the grout was taken

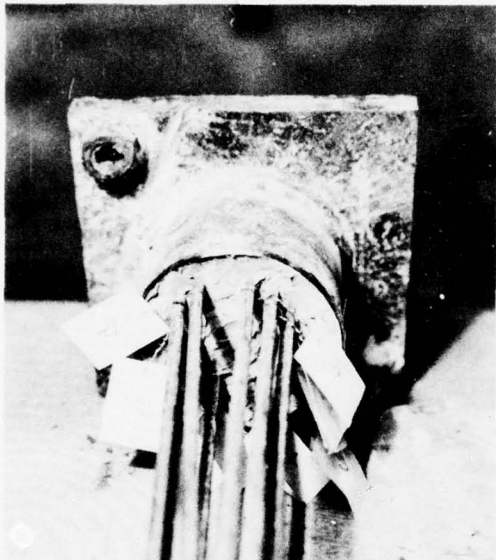
Photo 29. Heavy corrosion to the  
landward end anchorage of beam 19.  
Note rusted and flaked metal

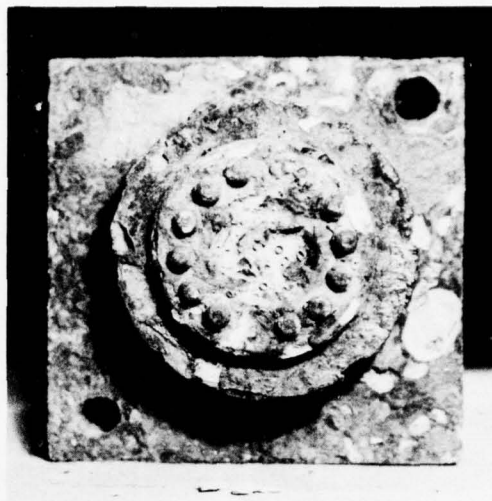
Photo 30. Heavy scarring and  
tarnishing on inside of the  
landward end anchorage plate  
of beam 19. Note light rust-  
ing with patches of heavy  
rusting

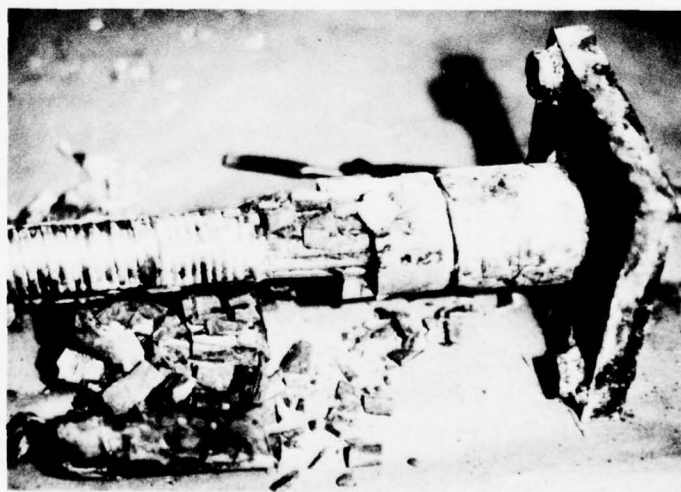
Photo 31. Grout beneath the seaward end funnel  
housing of beam 19 with less than 30 percent  
coverage of rust

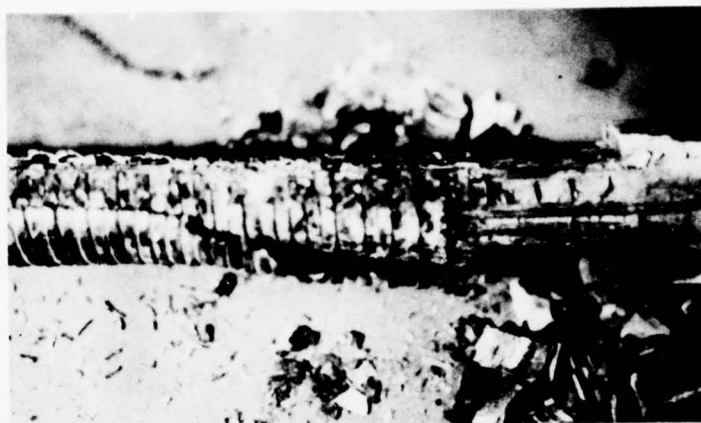
Photo 32. Heavily rust-stained grout beneath conduit at the seaward end of beam 19

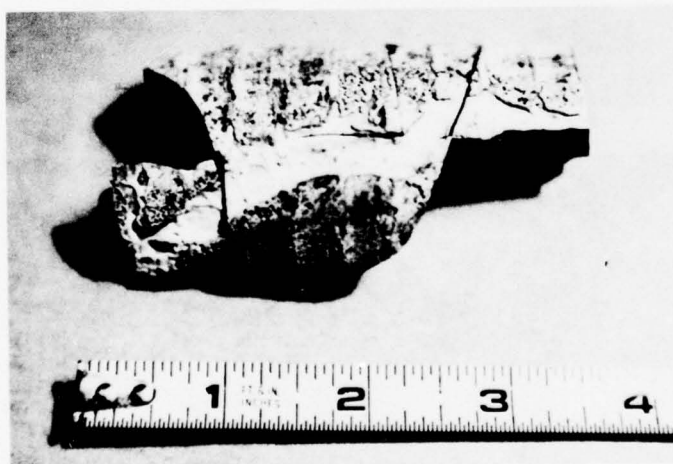
Photo 33. Air voids found at the grout-conduit interface of central section of beam 19

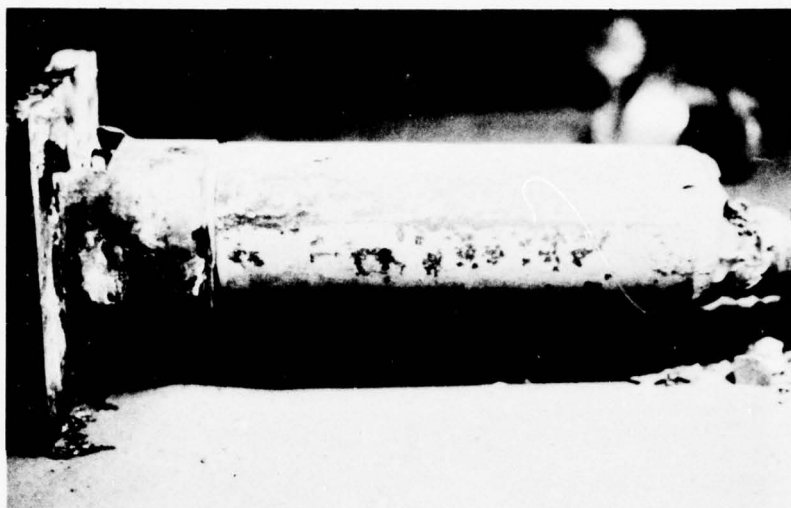
Photo 34. Rust stains on grout inside the landward end  
funnel in beam 19

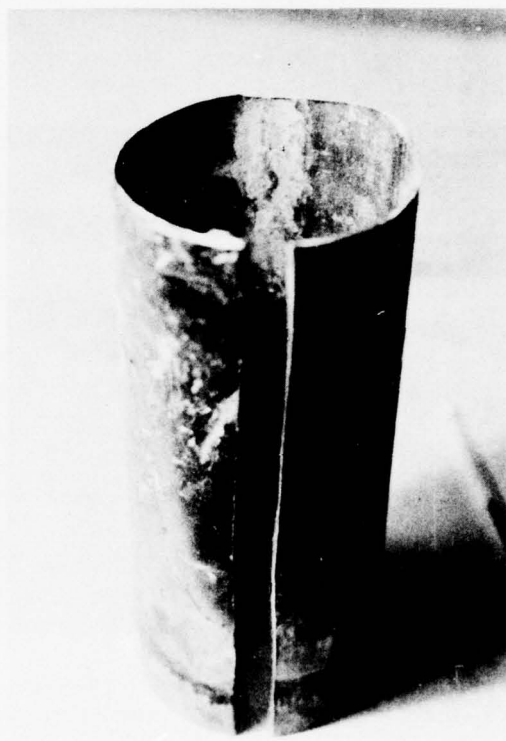
Photo 35. Rust on inside of the  
landward end funnel housing of  
beam 19

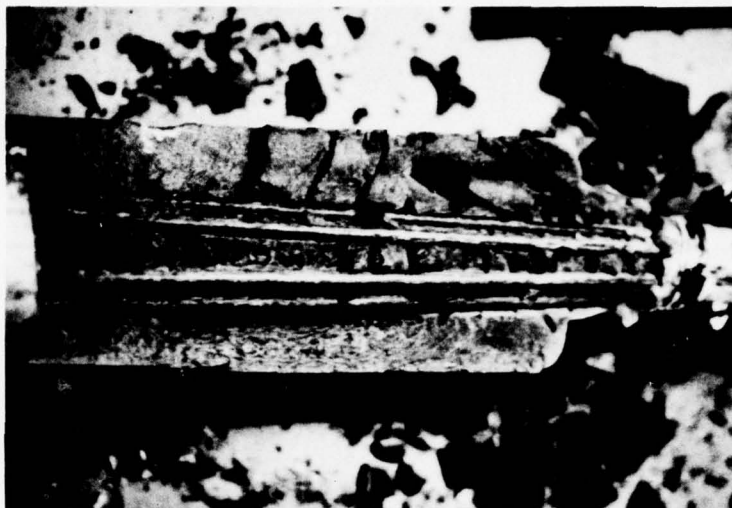
Photo 36. Strands at the landward end housing in beam 19. Note light to moderate rust with light pitting and small spots of heavy rust

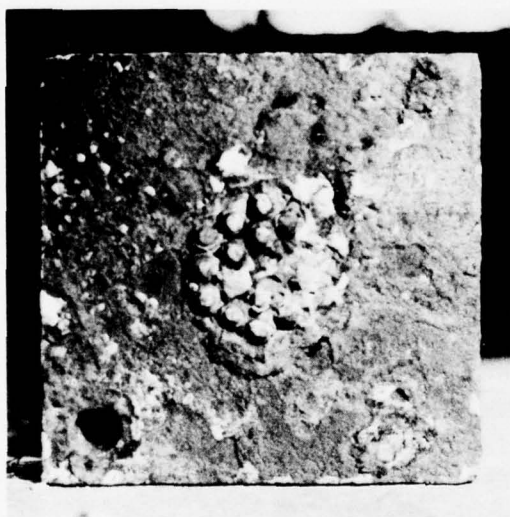
Photo 37. Heavy rust on outside face of the seaward anchorage and strands in beam 19

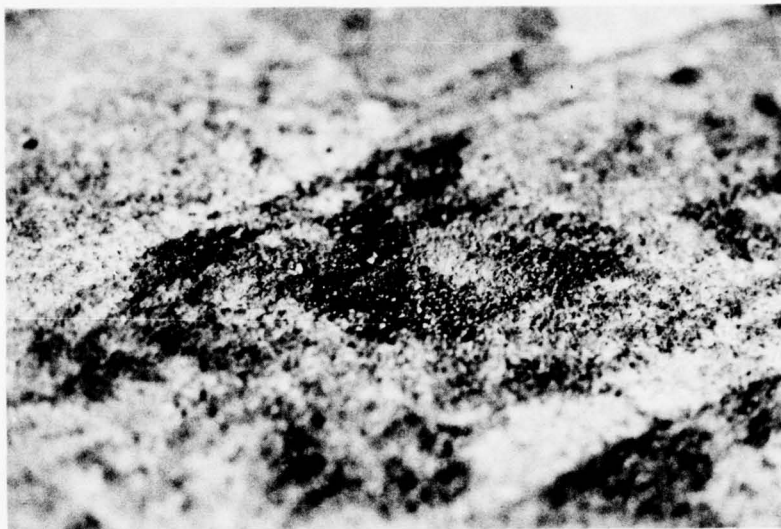
Photo 39. Detail of beam used in the second investigation showing moisture on the surface of the concrete

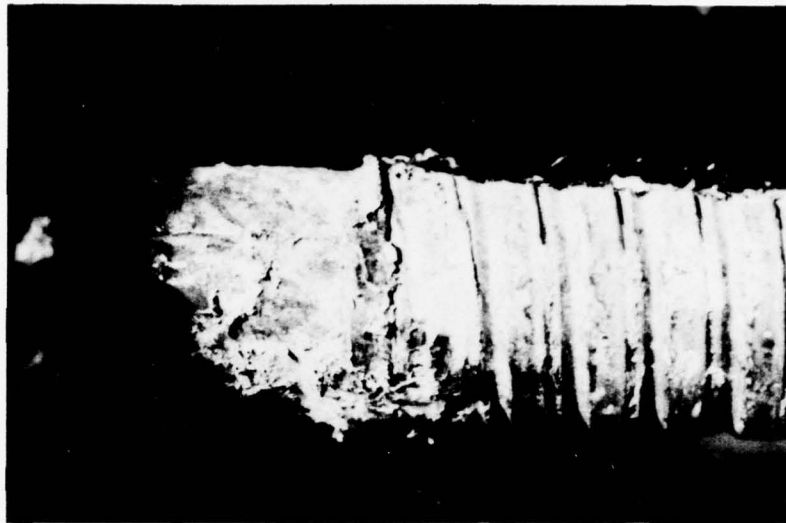
Photo 41. Rusting at the conduit/end anchorage joint  
in beam 6

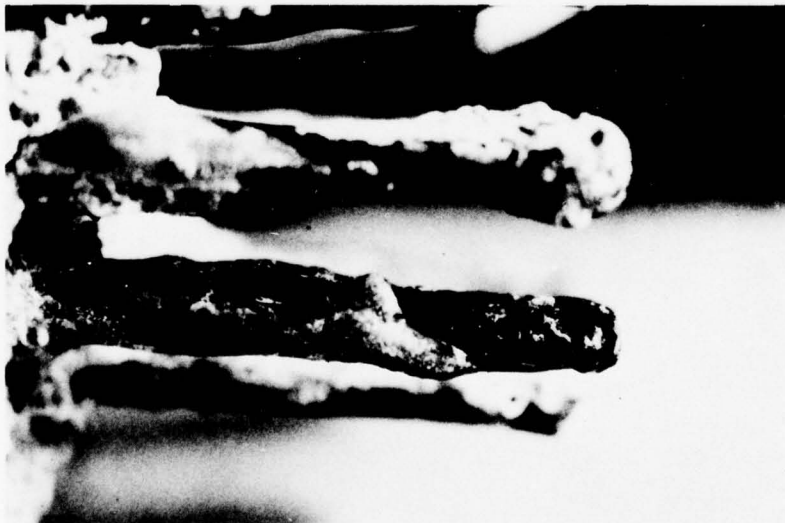
Photo 42. Epoxy cover on the strands at the  
outside end of beam 1

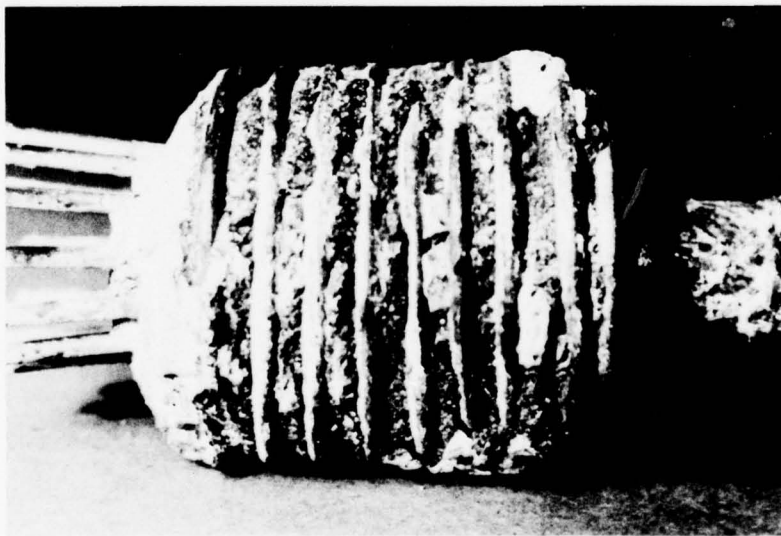
Photo 44. Landward end anchorage of beam 6. Note cement bonded to steel coils and tarnishing on coils but no rusting

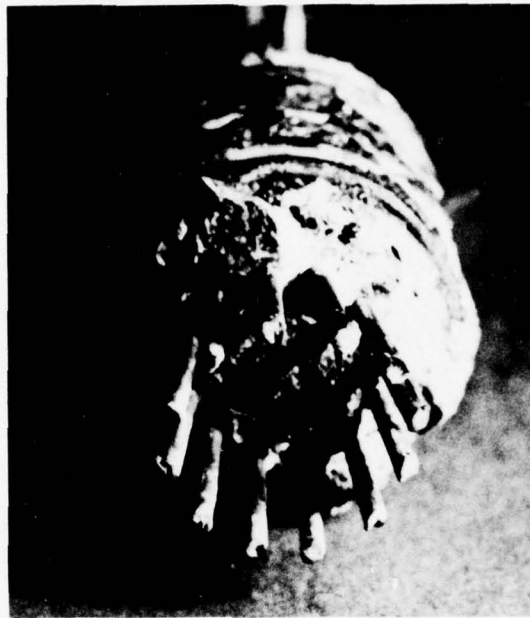
Photo 45. Strands extending 1-1/4 in.  
from the landward end anchorage of  
beam 6 completely free of rust

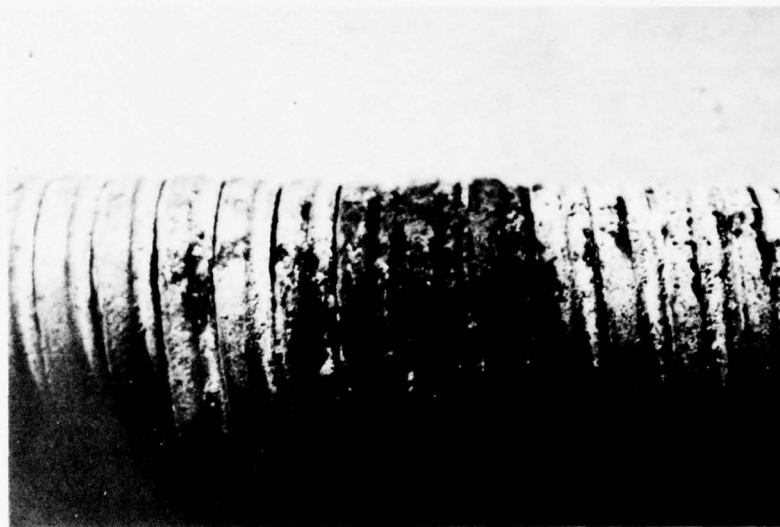
Photo 46. Heavily corroded area on midsection of  
conduit in beam 6

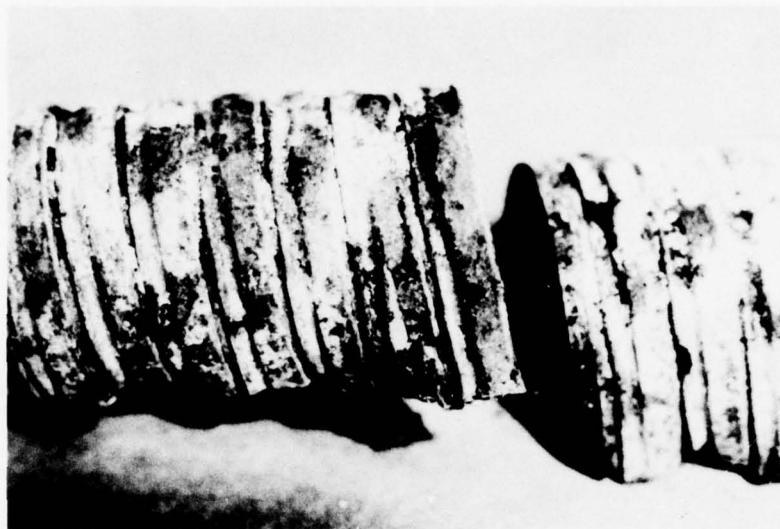
Photo 47. Midsection of conduit in beam 6 showing heavily corroded areas with holes when conduit had completely deteriorated

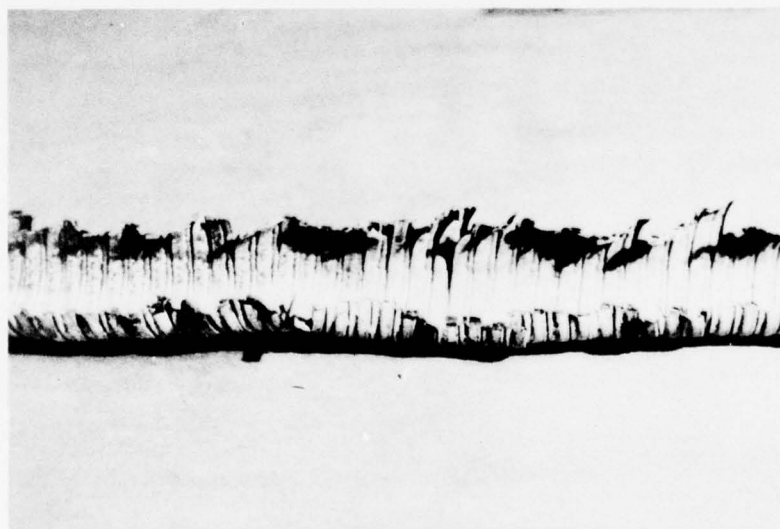
Photo 48. Inside of conduit at the end of beam 6. Note metallic luster still present on inside

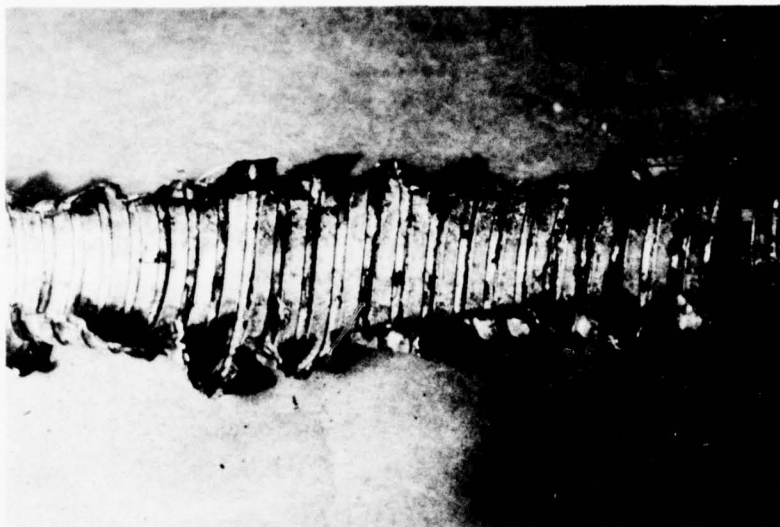
Photo 49. Inside of midsection of conduit in beam 6. Note rust on joints heavier and unrusted surface less lustrous than at ends (Photo 48)

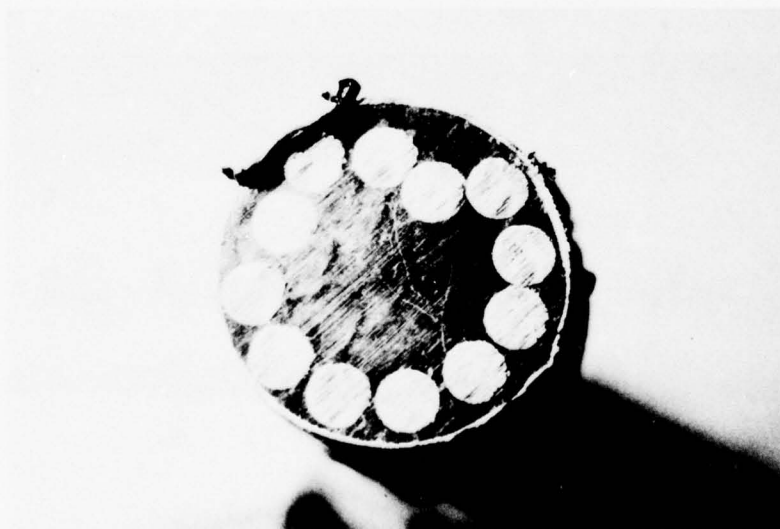
Photo 50. Landward end of conduit in beam 6 immediately after it was cut from conduit. Note closeness of individual strands to outside of conduit and contact of some strands with other strands and inside of the conduit

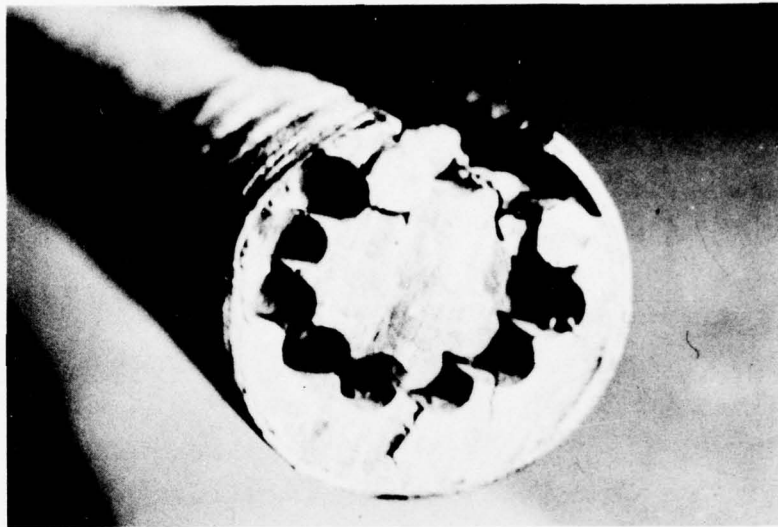
Photo 51. Strands at the seaward end of conduit in beam 6 after conduit was cut lengthwise. Note that 3 of the 12 strands did not shorten when the grout-steel bond failed

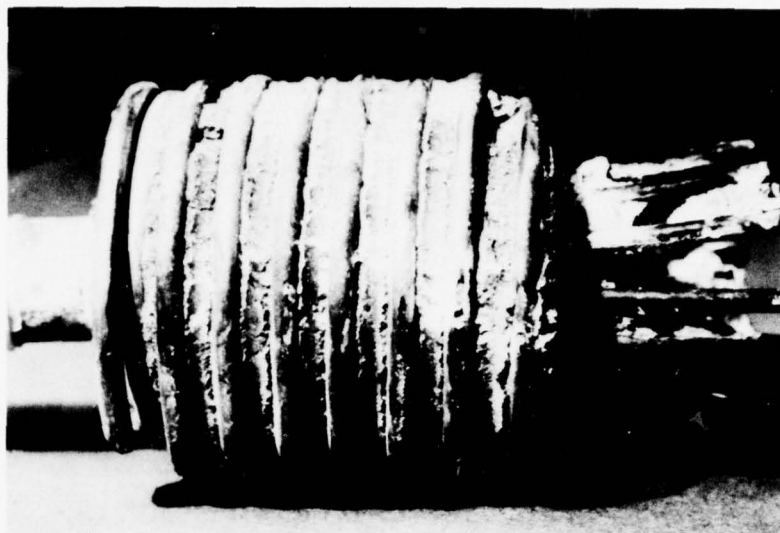
Photo 53. Steel coils of the seaward end anchorage of beam 6 lightly rusted at some spots and lustrous and unpitted in other areas

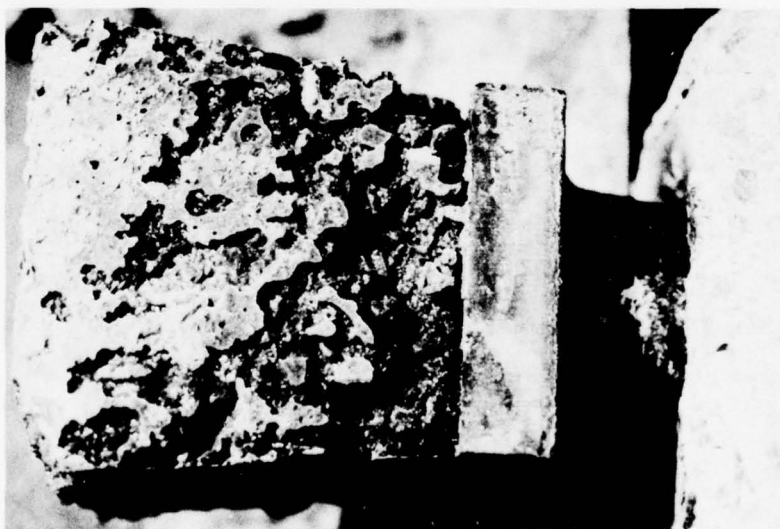
Photo 54. Poor compaction of the epoxy concrete end anchorage protection at the landward end of beam 11

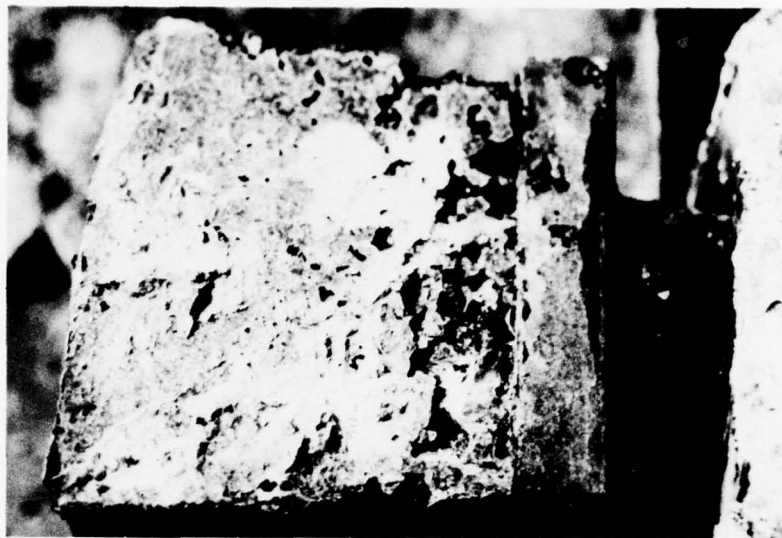
Photo 55. Poor compaction of the epoxy concrete end anchorage protection at the landward end of beam 11 showing rust on edge of anchor plate

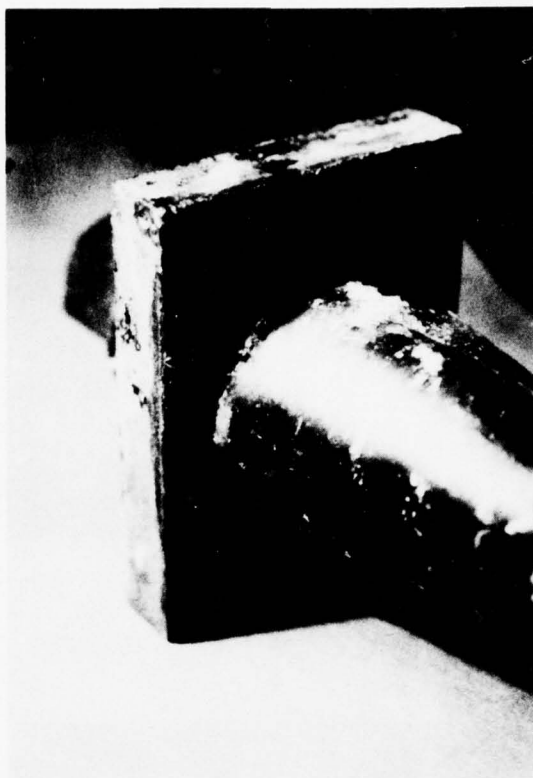
Photo 57. Inside face of the landward  
end anchorage plate of beam 11 not  
rusty but heavily tarnished

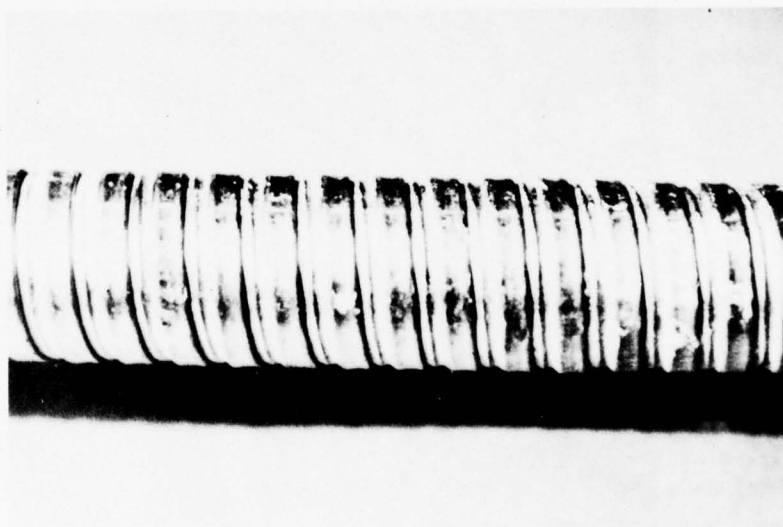
Photo 58. Highly lustrous condition of the conduit of  
beam 11, showing no rust and lack of any cement bonded  
to the surface of the metal

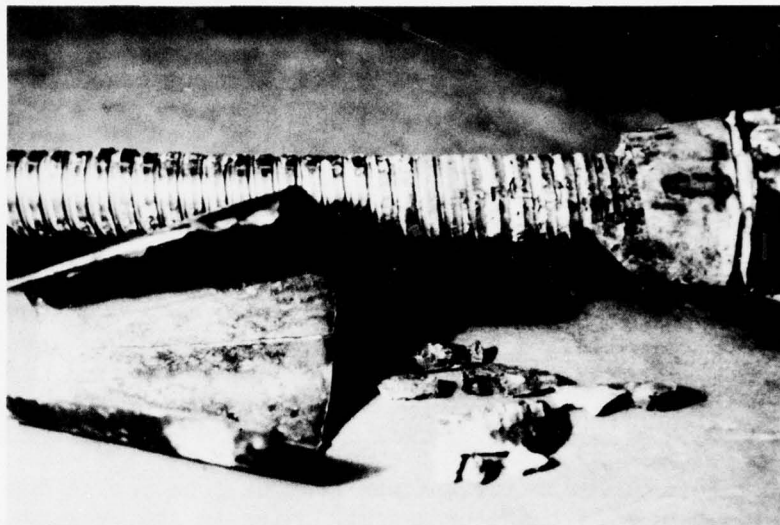
Photo 59. Rust on the bottoms of the funnel housing and conduit of beam 11 and pieces of grout that penetrated into the funnel housing

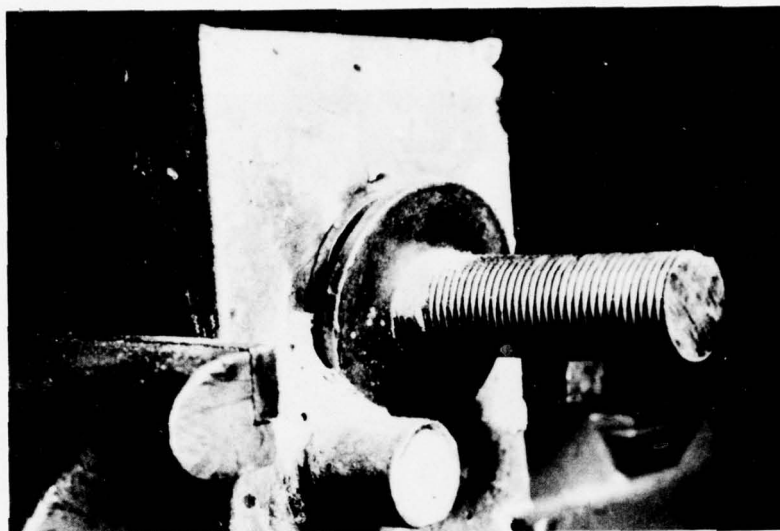
Photo 61. Rust on threads where grout from inside conduit in beam 11 came through the holes in the seaward end anchorage plate and washers. Note outside face of plate lightly rusted at top and free of rust at bottom

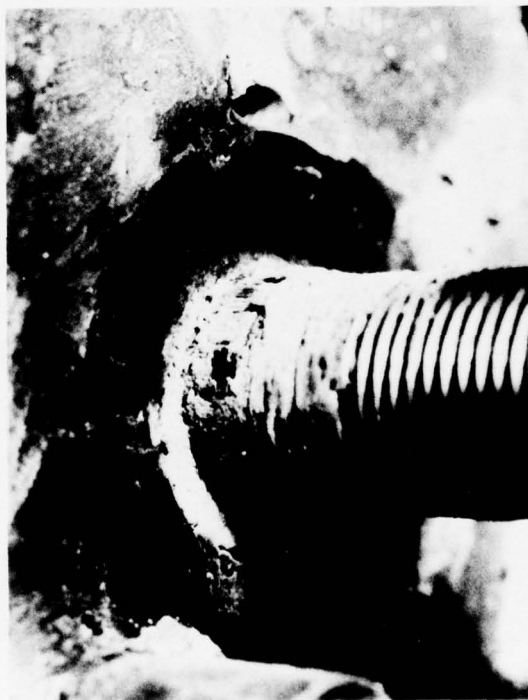
Photo 62. Detail of the seaward end anchorage plate in beam 11 not very rusted except at hole
